South Carolina Dam Failure Assessment and Advisement

DR-SC-4241

FEMA P-1801 / December 2016

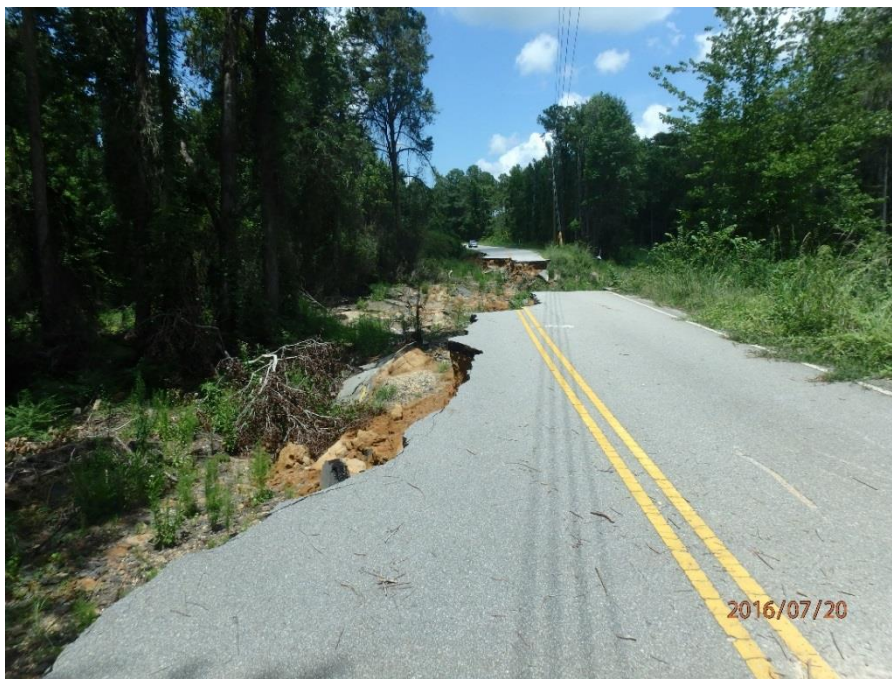
Figure 12 shows an example of overtopping failure at dam SCNONAME 14008. The foreground of the photo shows head cutting at the downstream toe and the background shows a complete failure where the head-cutting has propagated upstream through the road/dam embankment.

Figure 12: Head-Cutting of the Embankment at SCNONAME 14008 (Source: FEMA 2016)

The risk of overtopping failures can be reduced by increasing the spillway capacity. This will require a licensed and qualified engineer review the spillway capacity of the dam and develop a design to upgrade the spillway. The engineer should compare the design assumptions to current and projected watershed conditions to ensure that the dam height and spillway capacities are sufficient to meet projected needs. If the dam design is insufficient for projected future flows and downstream hazard creep, the engineer can recommend methods of upgrading the dam.

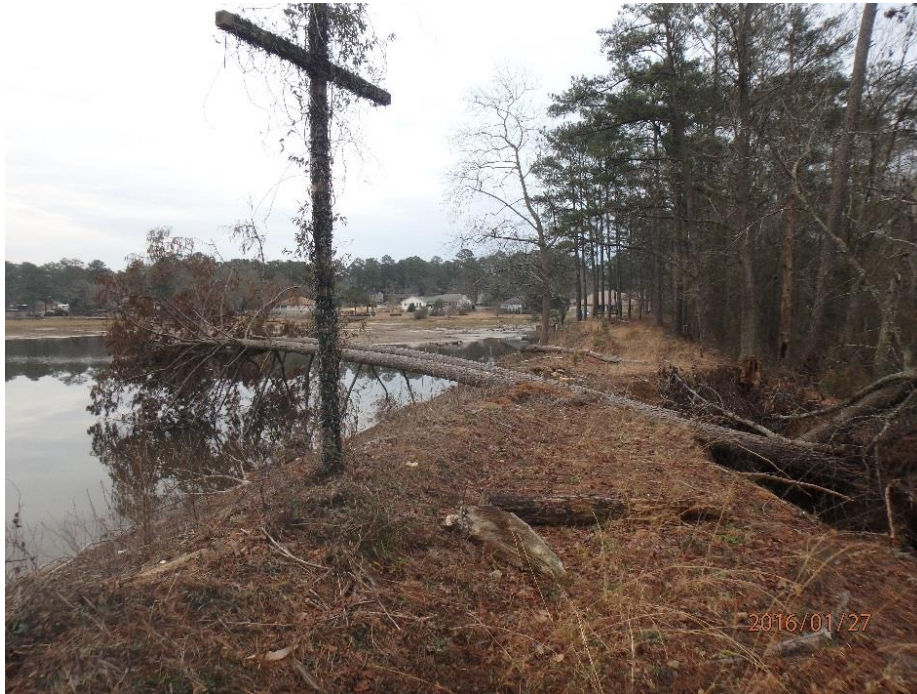
The potential for dam failure during overtopping typically increases when heavy vegetation is present on the crest and downstream face. Vegetation can result in the concentration of overtopping flows resulting in increased velocities and turbulence which increases erosion rates. Additionally the uprooting of woody vegetation by high winds or erosion can leave large holes which compromise the structural integrity of the dam, potentially exposing the phreatic line and increasing the rate of both internal and overtopping erosion. Figure 13 shows an example of a dam overtopping failure at Sunview Lake Dam where erosion of the downstream face was potentially exacerbated by an overturned tree. Additional issues caused by heavy vegetation on a dam include:

Figure 13. Overtopping Failure Exacerbated by Heavy Vegetation at Sunview Lake (Source: FEMA 2016)

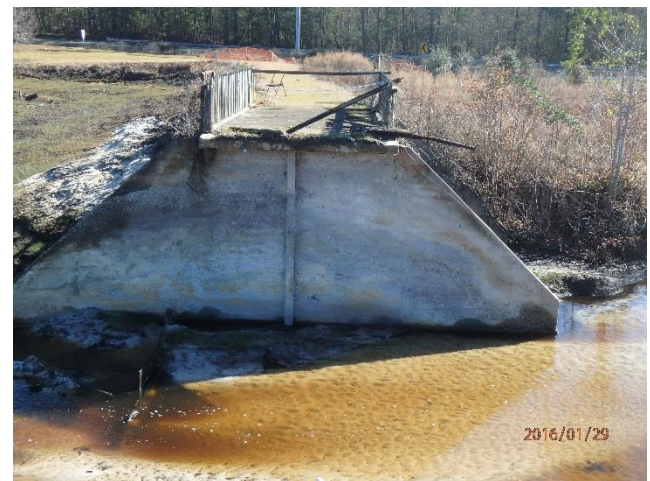
Structural failure was observed to contribute to the failure of 12 dams. Structural failures of earth dams can occur in the embankment itself or in its associated structures. The most apparent signs of embankment failure are cracking, settlement, and sliding. Sloughs, bulges, and cracks are indications of potential failure. Failures of spillways and drains can also cause an embankment to fail. Spillways, which are often constructed of concrete or stones and mortar, can fail when soils supporting their foundations erode, resulting in settlement and cracking of the spillway. Processes such as freezing and thawing, chemical reactions, and erosion can weaken the spillway materials, which also could lead to failure. An example of a structural failure where the connection between the concrete spillway and earthen embankment deteriorated can be seen at JW Smoaks Pond in Figure 15. This dam did not exhibit any significant signs of overtopping and had an open channel emergency spillway that was engaged and functioned properly. Another example of a structural failure can be seen on the next page in Figure 16 from Duffies Pond Dam. While this dam exhibited signs of overtopping, it was deemed a structural failure after discussion with the owner indicated that the dam was manually breached for a repair in that same location years ago, indicating the repair was likely the cause of failure.

Figure 15. Example of Structural Failure at JW Smoaks Pond (Source: FEMA 2016)
