South Carolina Dam Failure Assessment and Advisement

DR-SC-4241

FEMA P-1801 / December 2016

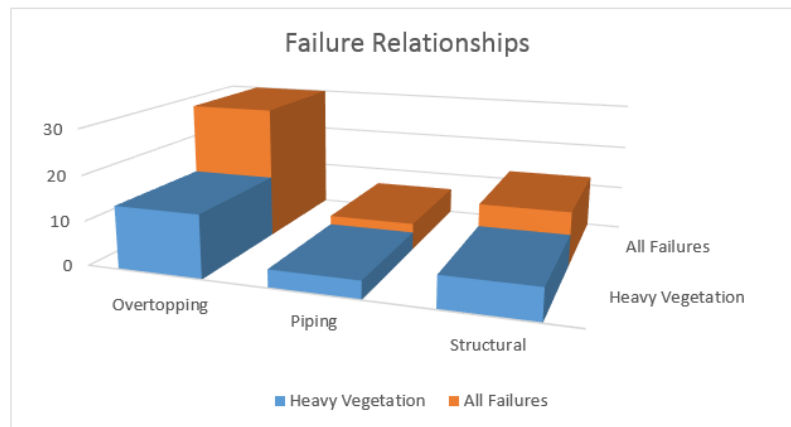
Figure 19: Failed Dams Having Heavy Woody Vegetation

This data was broken down further to determine the number of dams exhibiting heavy woody vegetation which can potentially contribute to failure as illustrated in Figure 19. Woody vegetation penetrations of earthen dams is all too often believed to be a routine maintenance situation, but penetrations of earthen dams and their appurtenances have been demonstrated to be causes of serious structural deterioration and distress that can result in failure of earthen dams. This data was further broken down by failure modes to illustrate the frequency of heavy vegetation on dams. Heavy vegetation was observed at 14 of 30 dams with a probable failure mode determined to be by overtopping, 4 of 6 dams with a probable failure mode determined to be by piping, and 7 of 12 dams with a probable failure mode determined to be structural failures.

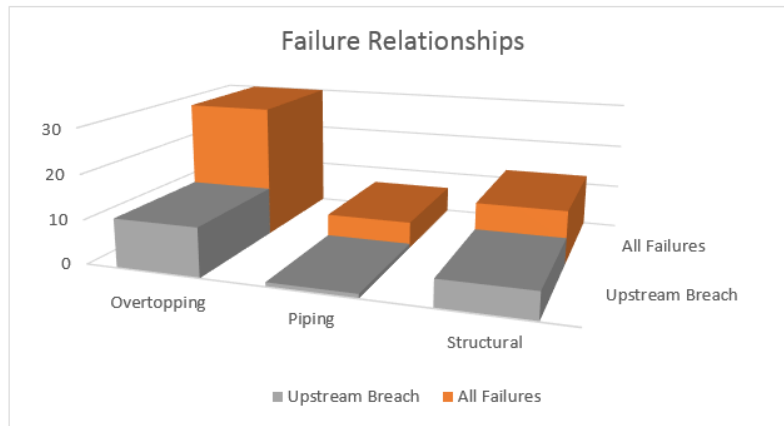
Figure 20: Failed Dams Where Upstream Breach Occurred

satellites. It is important to note that this data should not be used to say whether or not an upstream breach contributed to the downstream dam failure. In many cases, this is quite possible. However, in other cases the upstream dam may have breached after the downstream dam, thus not contributing to the downstream dam’s failure. This indicated that a large number of dams that most likely failed due to overtopping and structural failures were located downstream of another breached dam (Figure 20).
